RISK-BASED REMEDIATION OF LEAD AND CHROMIUM IMPACTED SEDIMENTS IN LAKE WABAN, WELLESLEY, MA: A CASE STUDY

Russell Schuck, Deborah Gevalt, Jennifer Mullen; Haley & Aldrich Inc. Boston, MA, USA,
Charles Menzie, Katherine Fogarty; Menzie Cura & Associates, Inc. Chelmsford, MA, USA

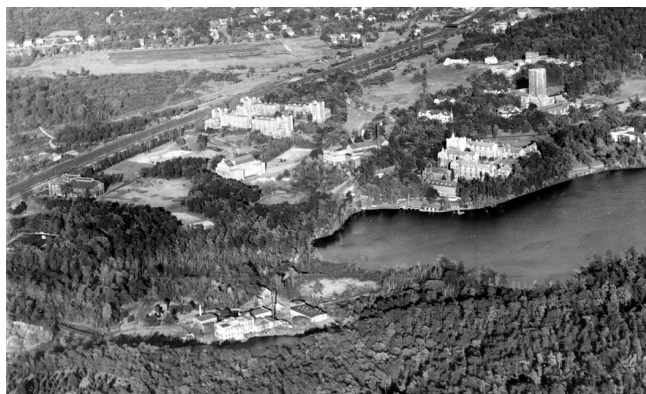
Figure 2. Aerial Photograph taken in 1931 looking east. Note the abandoned paint factory in the foreground.

The Former Henry Wood's Sons Paint Factory manufactured paint pigments on a parcel of land adjacent to Lake Waban from 1848 until approximately the mid-1920s. The former paint factory is visible on Figure 2, which is an aerial photograph taken in 1931. During factory operations, waste was regularly discharged into Lake Waban via Upper Waban Brook. The Former Henry Wood's Sons Paint Factory used and produced pigments based on heavy metal (e.g., lead, chromium, and barium) and other inorganic compounds. Paint pigment manufacturing using metal ores began at the uplands portion of the Site in 1848. "Historical records of the Wood's factory indicate that in the early 1880s, 6 tons of pigment were produced daily" (Clark, 1912). In general, waste disposal practices used at the former paint factory caused the sediments in Lake Waban to become contaminated with metals, primarily lead and chromium.

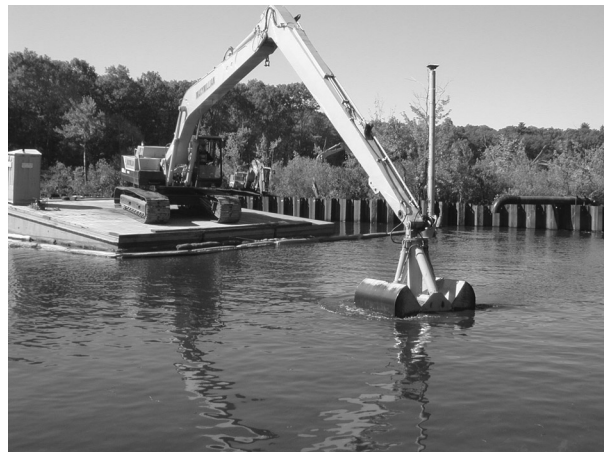
Figure 5. Excavator configured with an environmental clamshell dredge bucket. Note vertical GPS receiver antenna attached to bucket.

Dredging was completed using a barge-mounted excavator outfitted with a proprietary environmental clamshell bucket, guided by a global positioning system (GPS). Software was integrated to provide the real-time data necessary for precise remedial dredging. Figure 5 shows the excavator configuration.
